**PERFORMANCE DATA FOR SOME  
BITUMINOUS CONCRETE OVER-  
LAYS IN INDIANA**

**Joint  
Highway  
Research  
Project**

**PURDUE UNIVERSITY  
LAFAYETTE INDIANA**

by  
**W. H. GOETZ  
J. F.  
MCLAUGHLIN**

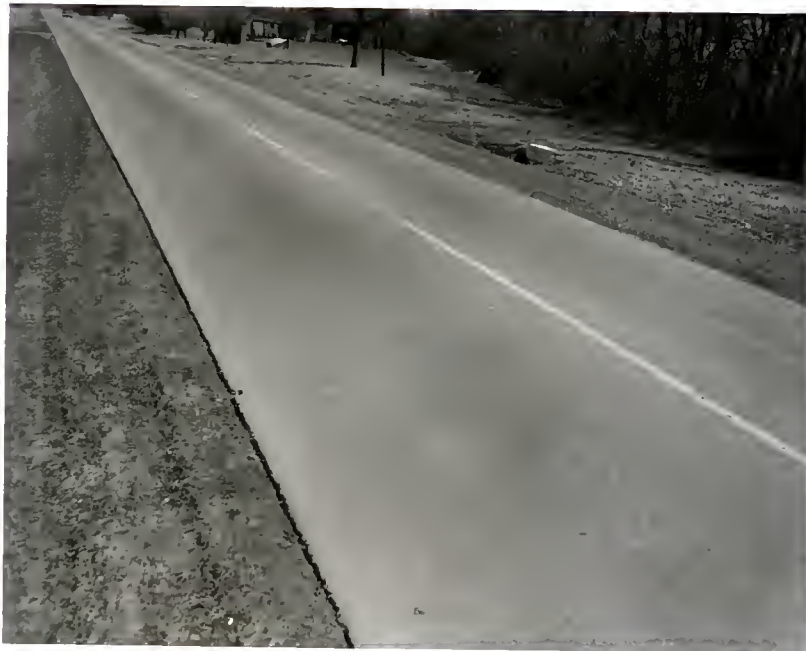
Figure 1. Bituminous Concrete Overlay on State Road 37.

This overlay on State Road 37 is now almost seven years old and, except for the presence of reflection cracks, the performance is satisfactory. Figure 1 shows a view of the road on the jointed concrete section. This is a good example of the successful use of this type of overlay under moderate to heavy moving traffic conditions. Figure 1 and subsequent illustrations showing condition of this road (Figures 2 to 4) are from pictures which were taken in March, 1957 when the overlay was about seven years old.

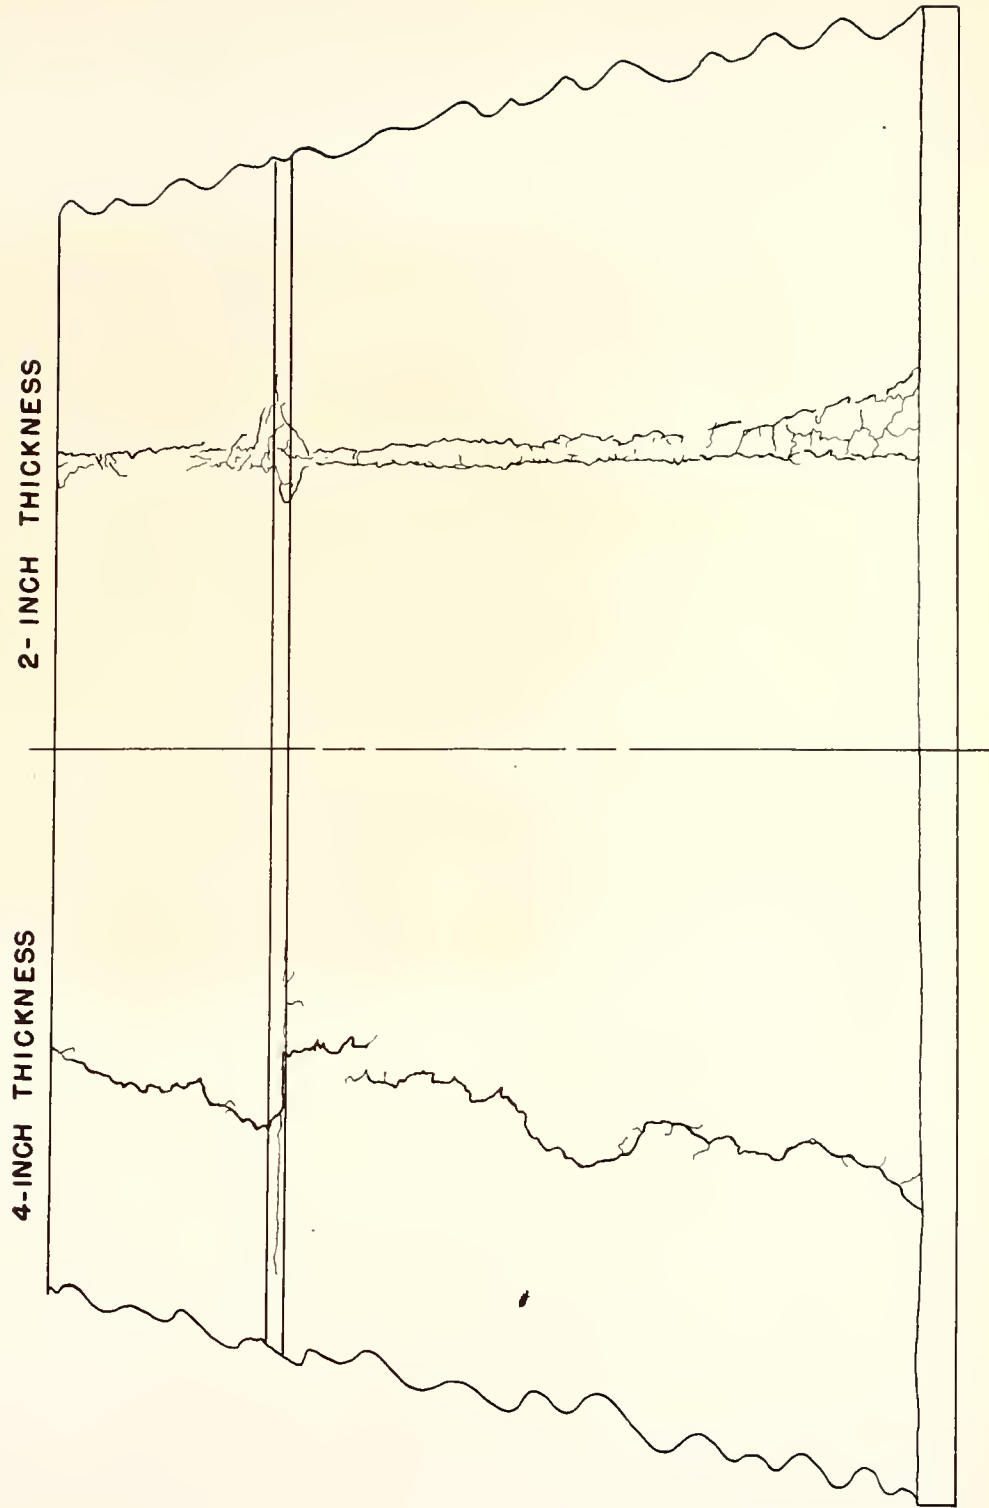
FIG. 2

All thickness designs on this road did not perform equally and there is evidence that heavy lays may be advantageous for some conditions. In Figure 2, for example there is shown for the jointed concrete pavement a "typical" reflection crack in the four-inch thick overlay on the left compared to a typical one in the two-inch thick overlay on the right. The crack in the two-inch thick overlay is more severe. It follows along the line of the joint and really is a system of multiple cracks with chunks of bituminous-concrete mixture beginning to be cracked off. The crack in the four-inch thick overlay, however, is a meandering one. It is, for the most part, a single crack and there are no signs of ravelling associated with it.

COMPARISON OF PERFORMANCE OF 2" AND 4" THICK  
OVERLAY ON JOINTED CONCRETE

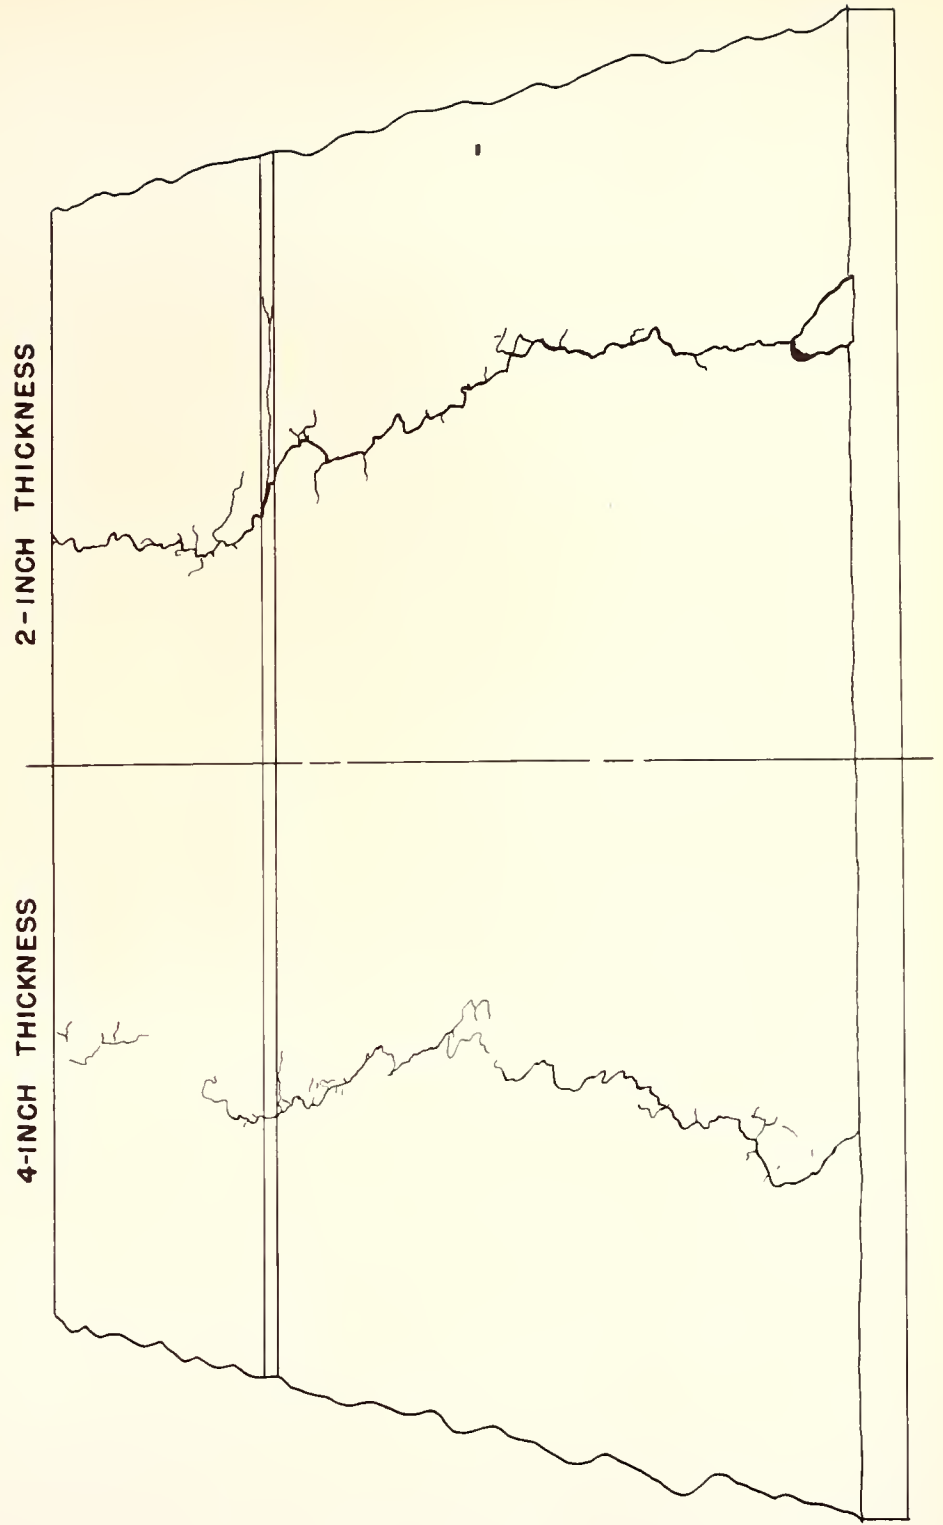
FIG. 3

Figure 3 shows a similar comparison for the bituminous-concrete overlay placed on the concrete pavement without transverse joints. This concrete has a fairly short crack interval. Before and after surveys indicated that most of the cracks in the concrete were reflected in the overlay. It may be seen from Figure 3, however, that these cracks are generally much less severe than those in the jointed concrete section. Again, the performance of the four-inch thick overlay is compared with the two-inch thick one with the four-inch thick section on the left. The condition of the cracks indicates some advantage for the thicker lay. But the difference is not as great as for the case with jointed concrete pavement.

COMPARISON OF PERFORMANCE OF 2" AND 4" THICK OVERLAY  
ON NON-JOINTED CONCRETE

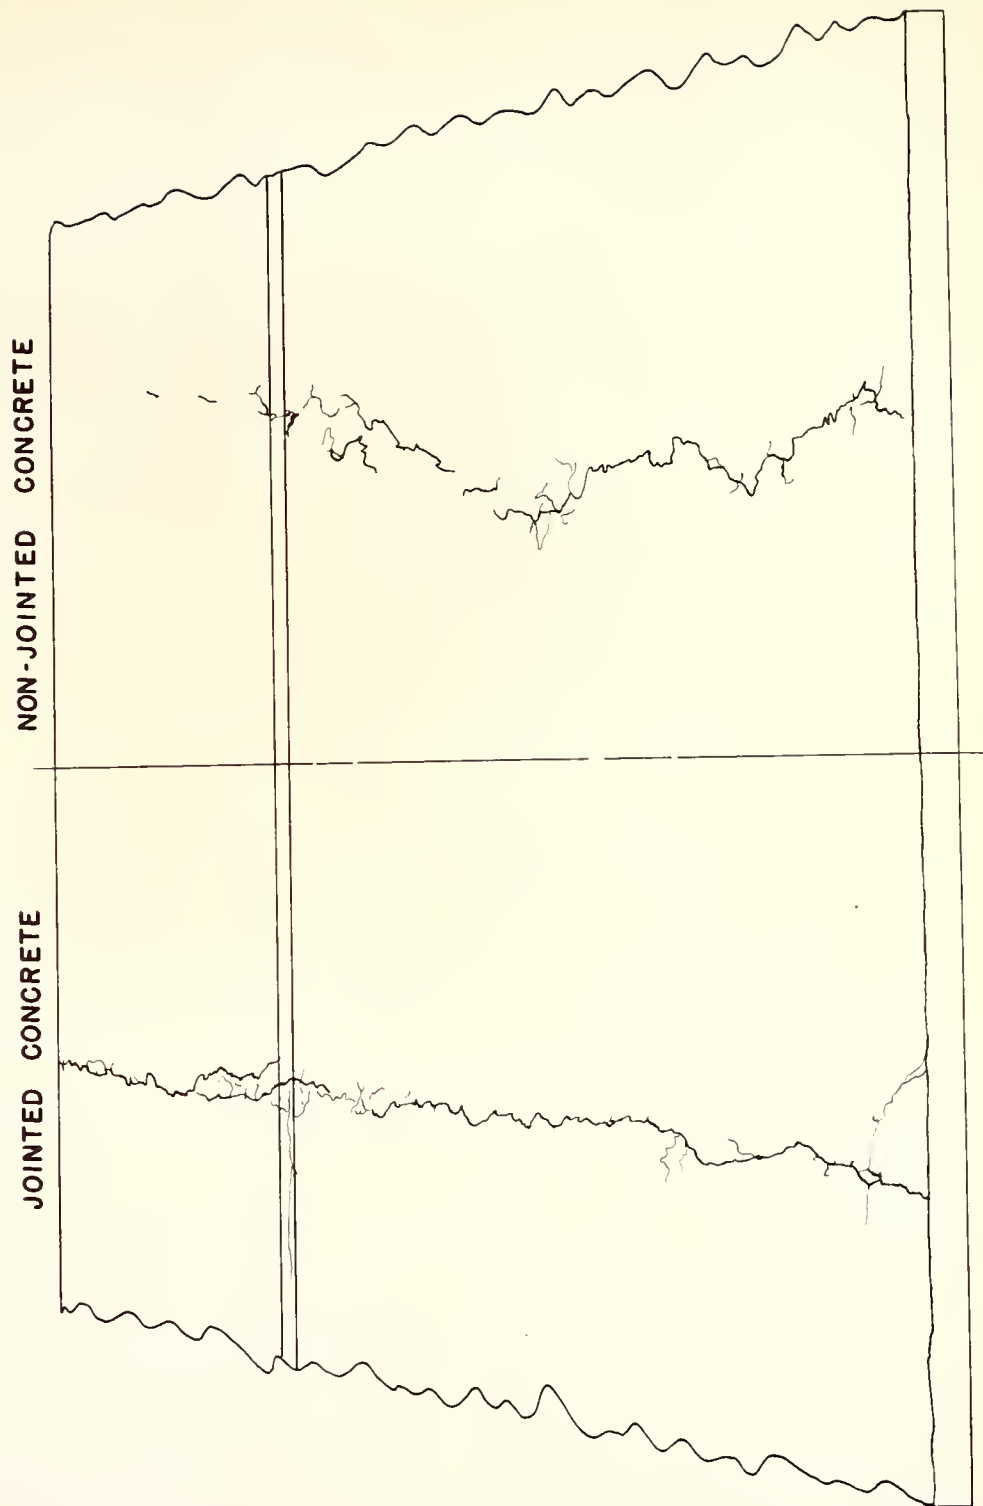
FIG. 4

A comparison between the performance of the three-inch thick overlay on jointed and non-jointed concrete is shown in Figure 4. The jointed concrete is on the left and the non-jointed concrete is on the right. For this thickness, which is very close to the standard design for the road, it is seen again that reflection cracking is less severe over non-jointed concrete.

COMPARISON OF PERFORMANCE OF 3-INCH THICK, OVERLAY  
ON JOINTED AND NON-JOINTED CONCRETE

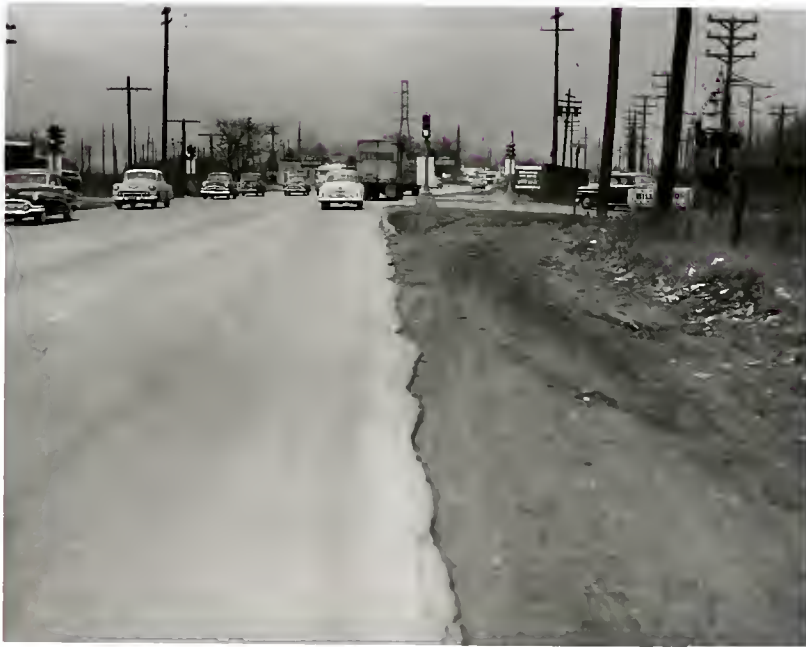
Figure 5. Overlay Performance at Intersection

An example of this is shown in Figure 5 which is a view looking west

at the westbound lanes of U. S. 12 and 20 near 151st Street and 15th Avenue just east of Gary. This picture was taken in November, 1955, at which time the overlay was three years old. The fact that the mixture had been subject to plastic movement seems evident from the pavement edge. The ruts were of the order of magnitude of a tenth of a foot. The mixture was literally being squeezed aside under the action of the wheel loads.

Evidence of lack of stability of some mixtures in some service conditions has been the development of ruts in the overlay in the wheel-track areas. This rutting, first investigated in the field in late 1952, was found to be present to some extent in many locations. It was present to an extent that could definitely be judged to be objectionable, however, in relatively few areas, each of which was subjected to much heavy, relatively slow-moving traffic. The condition was found to be the most severe at signalized intersections where the pavement and the overlay were subjected to stresses from braking traffic and to static loads.

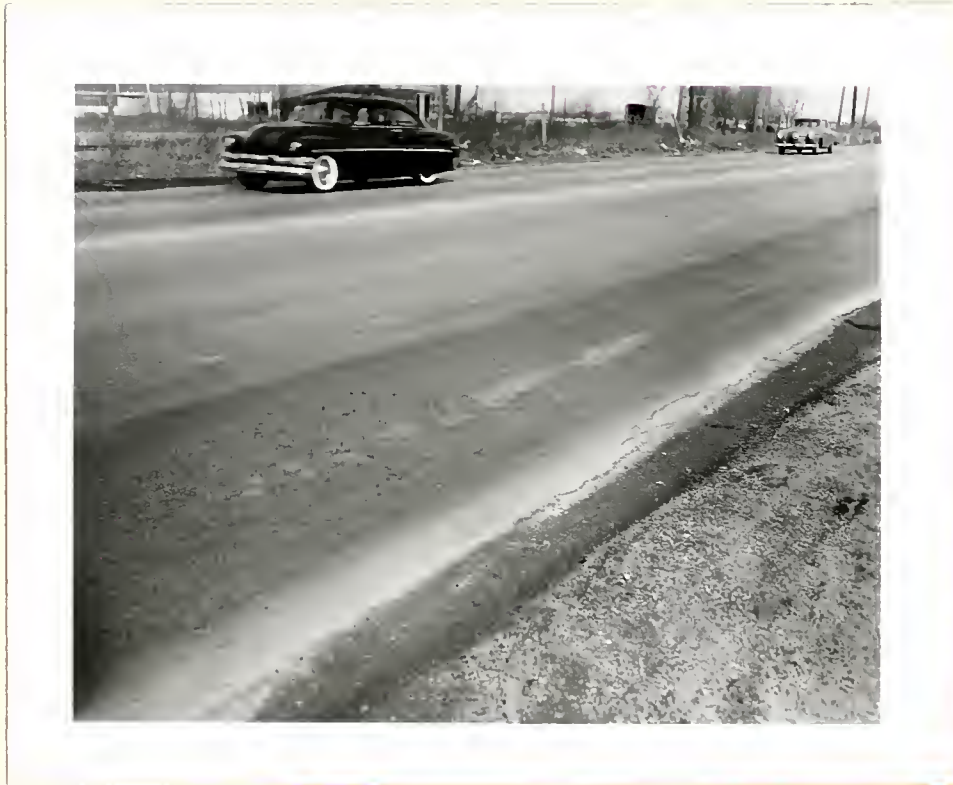
Figure 6. Concrete Exposed by Rutting

The same intersection in March, 1957, is shown in Figure 6. This view was taken just across the road from the previous one. The marks in the wheel track areas are not mud or patches, they show the underlying concrete. In this instance, the rutting has progressed to the ultimate. The entire thickness of the mixture has been displaced.

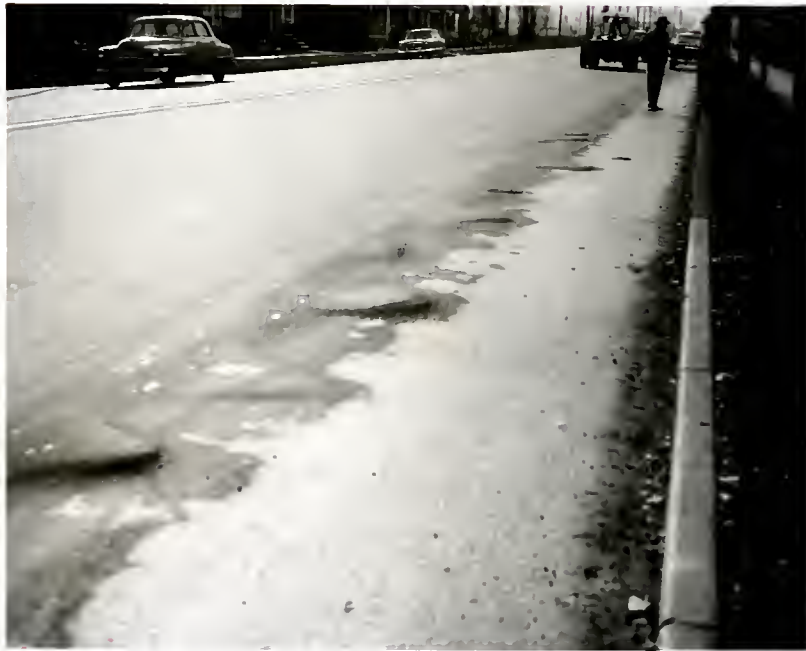
Figure 7. "Flow" of Bituminous Concrete

It took at least two years for much evidence of instability to show in the case illustrated in Figures 5 and 6. On another occasion the period was only a few months. Figure 7 shows a view looking south on Indianapolis Boulevard from the intersection with 151st Street in East Chicago. Again, the plastic nature of the mixture is illustrated by the apparent flow of the bituminous concrete.

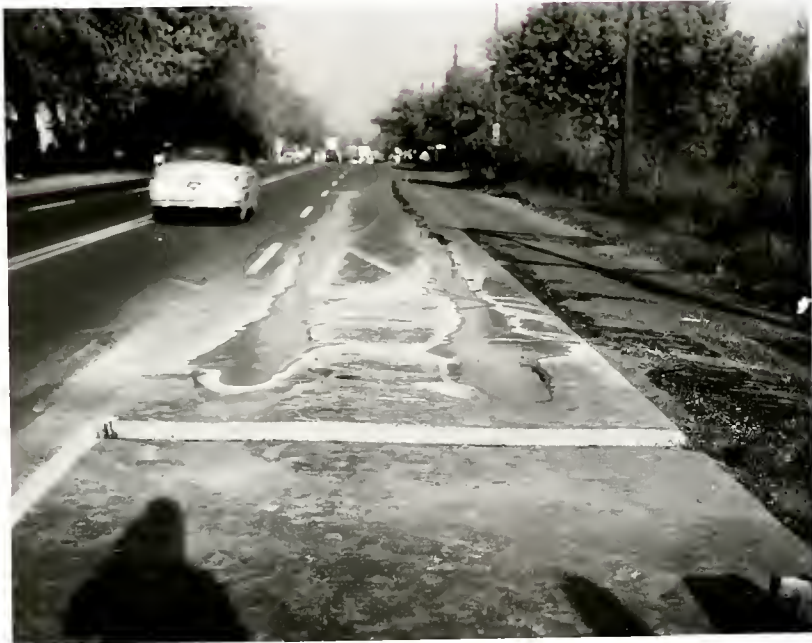
Figure 8. Trench Cut in Bituminous Overlay

Other locations in the State where extremely severe traffic conditions exist have shown similar results. Figure 8 shows one of two trenches cut for the full depth of the resurfacing across the outside lane of pavement on U. S. 40 near Indianapolis. The pavement distortion can be seen both from the cut face of the trench and from the water on the pavement which is ponded in the ruts in the wheel-track areas. This trench was cut approximately 750 feet back from the nearest signalized intersection. Another trench cut at the intersection showed more distortion than the case illustrated.

This trenching operation, in addition to enabling one to measure rutting, showed that the overlay had spread out in a transverse direction so that it

extended some six inches beyond the edge of the concrete to which it was placed during construction. Secondly, it was found from an examination of the sawed face that both the binder and surface layers were distorted in the wheel-track areas. Thirdly, and this is illustrated in Figure 9, it was found from density measurements made on samples taken at closely-spaced intervals across the traffic lane that the density of the mixture was essentially the same regardless of sample position.

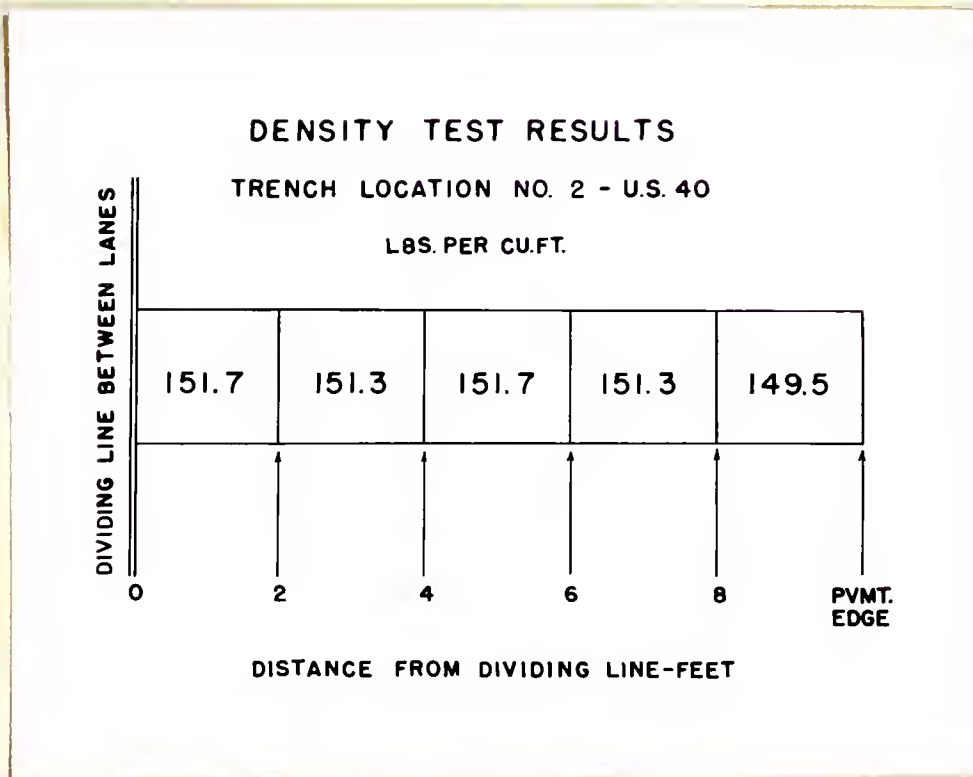
Figure 9.

In Figure 9 are grouped the density data for two-foot intervals across the trench. The low value that was observed near the pavement edge includes some samples that were obviously under-compacted.

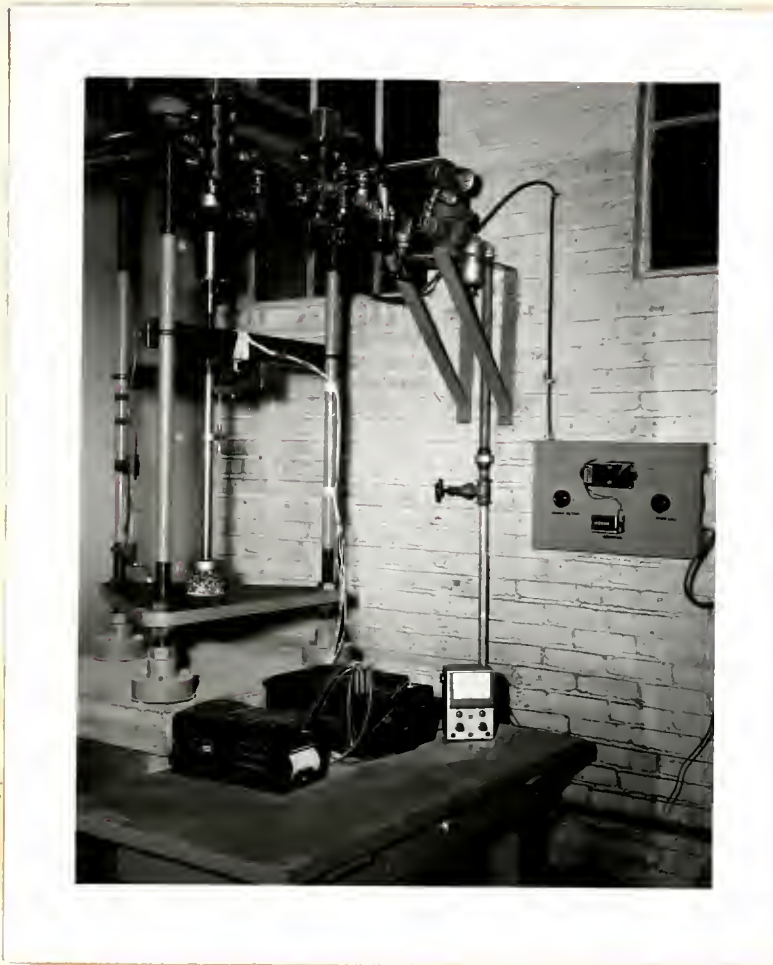
The equipment and test set-up that we have been using to measure the deformation characteristics of a bituminous-concrete specimen under repeated applications of load is shown in Figure 10. Basically, this apparatus consists of an air motor mounted in a loading frame. Suitable valves and controls are present to admit compressed air to the air motor for a time interval which may be pre-set. The load is transmitted from the air motor to a shaft which in turn transmit load to the specimen. At the end of the pre-set time interval, during which the load is maintained constant, the inlet air valve to the motor closes and an exhaust valve opens, releasing the air, and hence quickly removing the load from the specimen. After another time interval which can also be pre-set, the cycle is automatically repeated. One can make

Figure 10. Repeated Load Test Apparatus

this sort of test at various temperatures and with various loads. As the specimen is repeatedly loaded it accumulates a permanent deformation which may be comparable to the tendency to rut that has been observed.

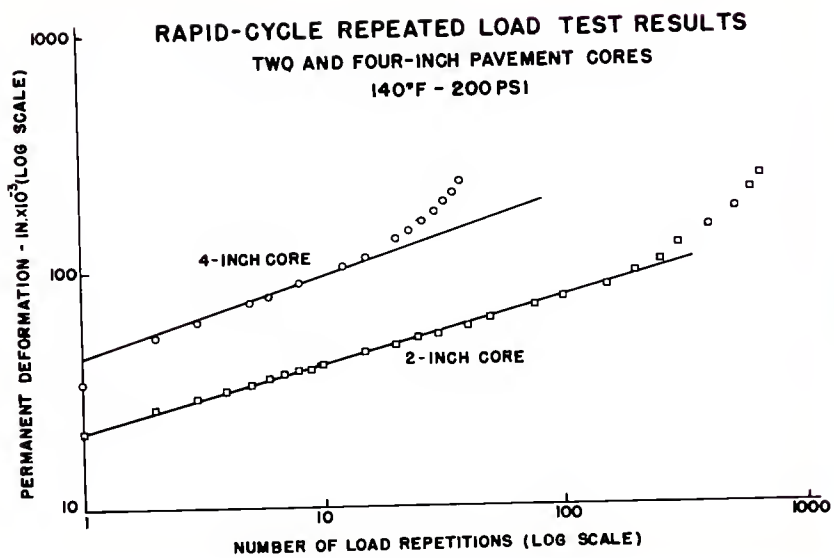
By keeping a record of the accumulation of this permanent deformation during the test, one may plot a graph of the sort shown in Figure 11. In this figure is shown a plot of log cumulative permanent deformation on the vertical scale versus the logarithm of the number of load repetitions on the horizontal scale. This particular illustration is from tests on two and four-inch thick cores of AH-Binder and Type B surface tested at 140° F and under a contact pressure of 200 psi. Without going into any detail, we will comment only that it is believed that the slope of these lines and the point on the line at which the data begin their upward deviation may have some significance with respect to the potential ability of the mixture to withstand repeated applications of load. This test method is still in the development stage but it shows great promise. Perhaps at some future Road School there will be further progress to be reported on this subject.
